# Ceramic Welding Used With High Temperature CCTV in Advanced Repair Technique for Glass Furnaces

By WILLIAM J. LANG, Sales Manager  
Lenox Instrument Co., Inc., Trevose, PA 19053-3427

*This article describes a technique which uses a closed-circuit television (CCTV) monitoring system to examine the refractory lining of a furnace prior to repair. This technique, known as ceramic welding, uses oxygen-rich refractory particles and fusion in a highly exothermic reaction to repair the furnace linings.*

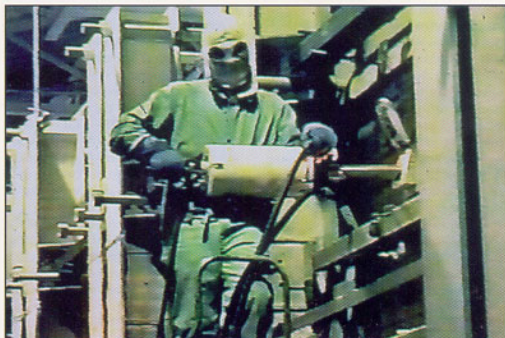
Fig. 1 Wearing fire-retardant gear, a technician inserts the periscope of the CCTV system into the regenerator chamber of a glass furnace to view checker packs used to regenerate heat during manufacture of glass.

water-cooled periscope, which has a 90° lens at its tip, through an existing or specially-drilled "peep hole" in the furnace wall (Fig. 1). A technician can remotely control a motorized iris and spot filter in the lens system to easily adjust the amount of light admitted to the camera, helping ensure high-quality images in a wide range of light conditions and avoiding problems like "whiteout" (loss of picture due to intense light). A series of achromatic relay lenses within the periscope carries the images back to a compact, solid state CCD camera within a high tem-
