FURNACE CAMERAS ASSIST IN NO_x REDUCTION

Furnace cameras are one tool Entergy is using in the fight to reduce emissions. Entergy recently installed a camera manufactured by Lenox Instrument Company on the Unit 2 boiler at the company's Sabine plant, Bridge City, Texas. Entergy has found that using the camera has not only helped them reduce NO_x emissions, but it has also aided in combustion tuning and monitoring the operation of other NO_x reduction equipment.

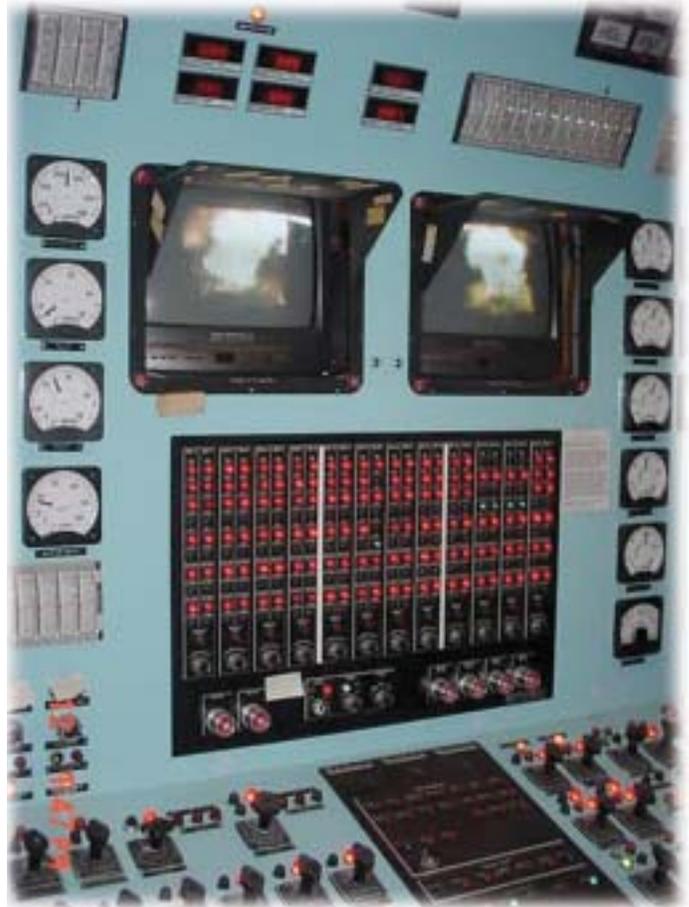
Sabine's furnace control panel

The color furnace cameras installed at Sabine provide a "real-time" image of what is actually happening inside the furnace, thereby allowing the operators to view problems instantly such as flame instability, incomplete combustion and poor flame distribution.
